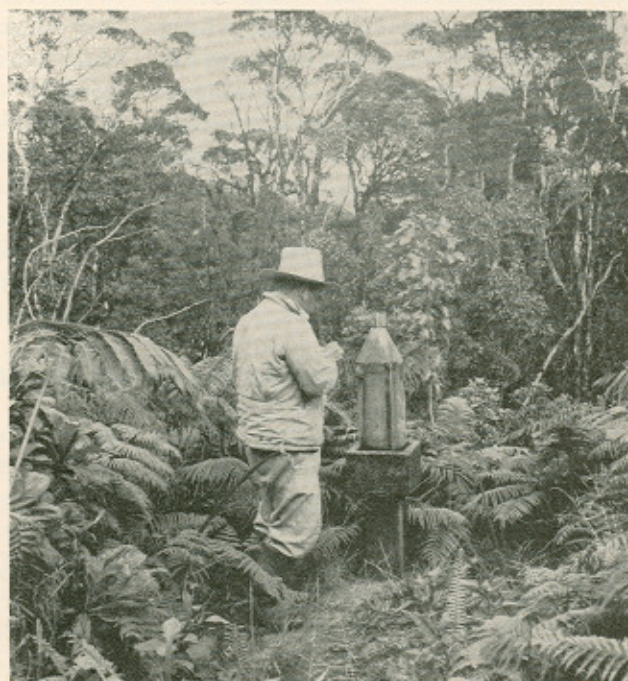
Figure 1. Rain gage No. 342, Puohakamoa No. 2, on East Maui. Gage is located in a clearing in the rain-forest where annual rainfall is 250 inches. Trees in background are ohia lehua. The diameter of the collecting ring of the gage is about two inches, and the ratio of collecting ring area to storage cylinder area is 1:10.

In the rough forested areas of Hawaii, it is impossible to find locations for rain gages the exposure of which fulfills the requirements usually met in mainland United States. The rain gage shown in Figure 1 is a typical mountain gage, placed in a small natural clearing in a thickly forested area.

The measurements of rain at such gages are necessarily rough. In the case of gages having a 1:10 ratio, depth of water collected cannot be read closer than the nearest whole inch of rain. This means, however, that the ratio of error to total catch is comparable to standard gage readings in areas of lower rainfall. The readings themselves are subject to a multitude of errors. Since the depth read must be multiplied by the ratio of catchment to gage area, there is sometimes a possibility that the proper multiplication was not made.
