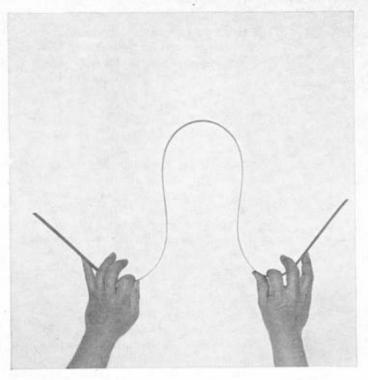
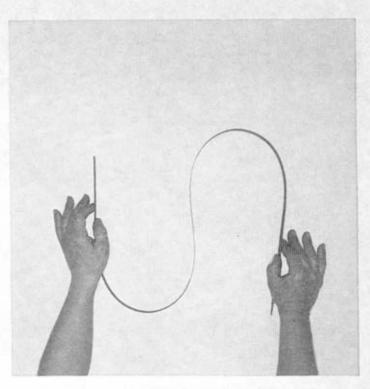
as possible. In each of the four cases shown here this shape is a sine-generated curve and indeed a good model of a river meander.

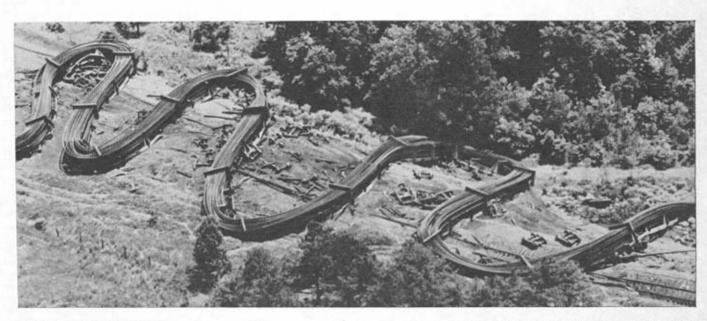
CATASTROPHIC EXAMPLE of a sine-generated curve on a much larger scale was provided by the wreck of a Southern Railway freight train near Greenville, S.C., on May 31, 1965. Thirty adjacent flatcars carried as their load 700-foot sections of track rails chained in a bundle to the car beds. The train, pulled by five locomotives, collided with a bulldozer and was derailed. The violent

compressive strain folded the trainload of rails into the drastically foreshortened configuration shown in this aerial photograph. The elastic properties of the steel rails tended to minimize total bending exactly as in the case of the spring-steel strip shown at top of these two pages, and the wrecked train assumed the shape of a sine-generated curve that distributed the bending as uniformly as possible.
