## River Channel Change with Time: An Example

Address as Retiring President of The Geological Society of America, Minneapolis, Minnesota, November 1972

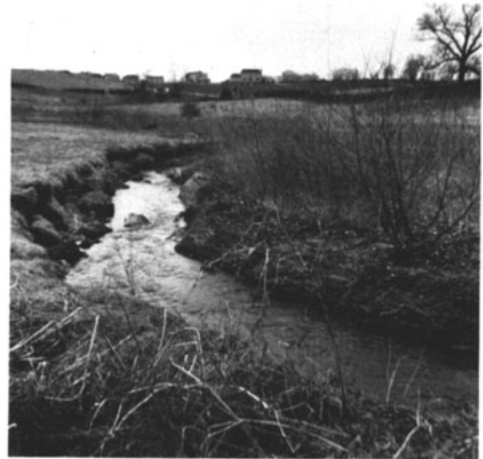
Figure 5. 1971 view of same reach shown in Figure 4. Note greater prominence of blocks of sod falling off left bank. Also growth of willow brush on point bar to right.

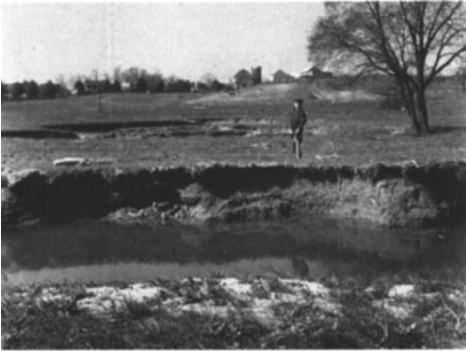
Figure 6. Downvalley view near section 1-2 in 1953. Compare with Figure 7.

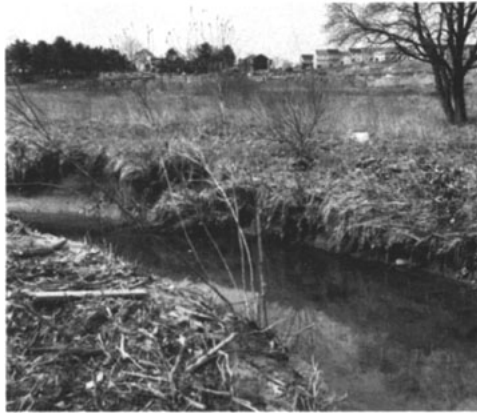
Figure 7. 1971 view near section 1-2. Note flood debris in left foreground, and willow brush. New housing under construction in background.

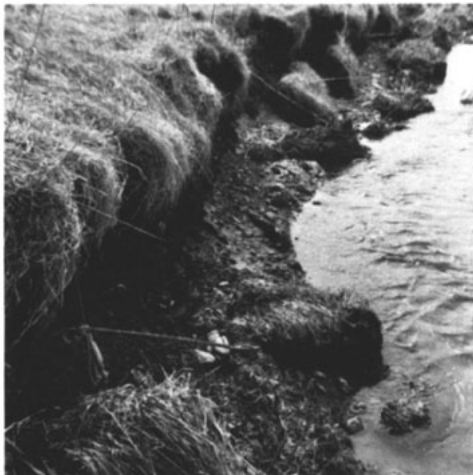
Figure 8. Closeup of retreating bank near section 44A-45 in 1971. Iron pin originally set well away from bank has been exposed by bank retreat and is now bent over into channel. Sod lumps undercut by bank retreat fall into channel.

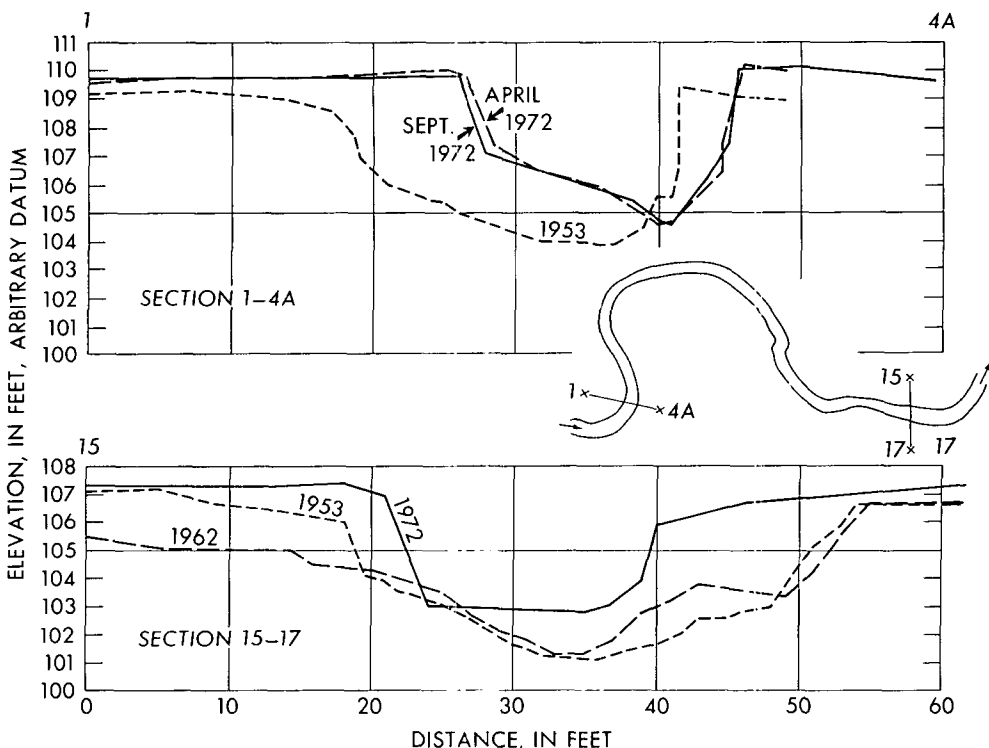
Figure 11. Selected cross sections of the channel of Watts Branch, section 1-4A (upper) and section 15-17 (lower).

Deposition in the channel was not confined to point bars convex in plan view. Section 15-17 (Fig. 11), for example progressively built both banks channelward, increasing the steepness at the same time. This occurred despite the fact that the section is located in the upstream part of a meander curve both before and after the artificial cutoff made by the sewer construction upstream in 1961.

To demonstrate that successive small rises, not large floods, account for the progressive alteration of channel, Figure 11 shows two successive surveys of section 1-4A in 1972. The surveys were made in April and September; between those surveys (in August), the largest flood of record occurred, associated with Hurricane Agnes. The section was changed so little that differences are within the usual limit of survey accuracy.
