## River Channel Change with Time: An Example

Address as Retiring President of The Geological Society of America, Minneapolis, Minnesota, November 1972

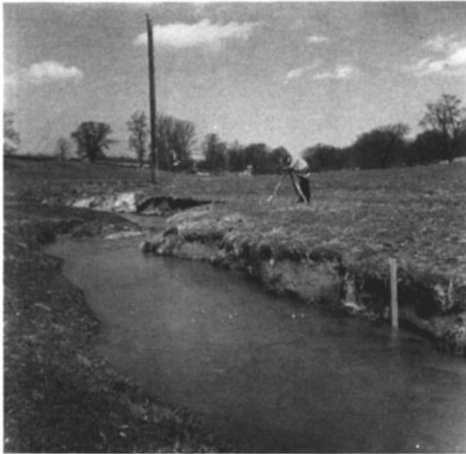
Figure 3. Watts Branch in May 1953, looking upstream toward area where cross sections were established. Staff gage at natural section in right foreground and where bankfull stage was determined.

The photographs of Figures 3 through 9 show the character of the stream and valley and the visual changes that occurred. Note especially the houses appearing in the background of the later pictures.

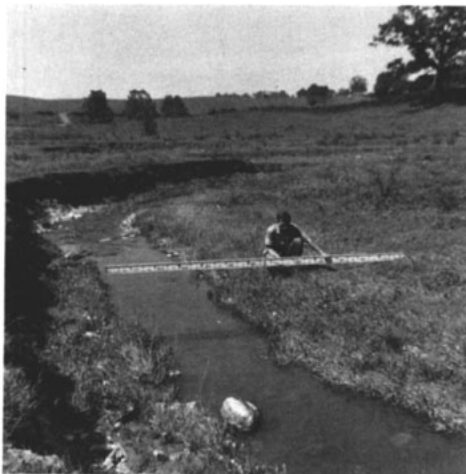
Figure 4. View downstream in 1959 at section 44A-45 for comparison with Figure 5.

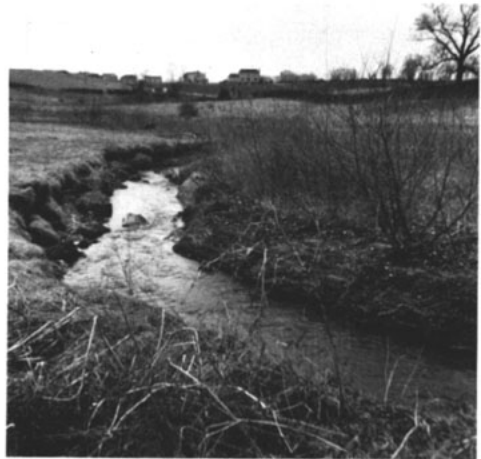
Figure 5. 1971 view of same reach shown in Figure 4. Note greater prominence of blocks of sod falling off left bank. Also growth of willow brush on point bar to right.

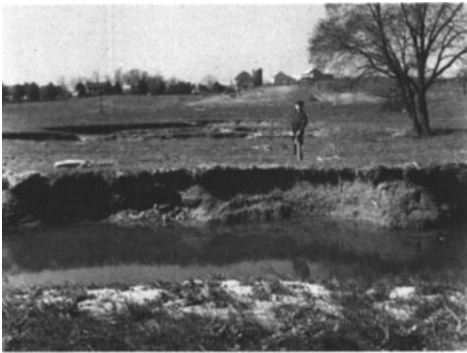
Figure 6. Downvalley view near section 1-2 in 1953. Compare with Figure 7.

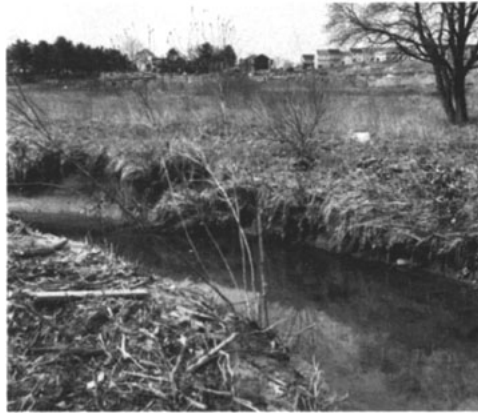
Figure 7. 1971 view near section 1-2. Note flood debris in left foreground, and willow brush. New housing under construction in background.

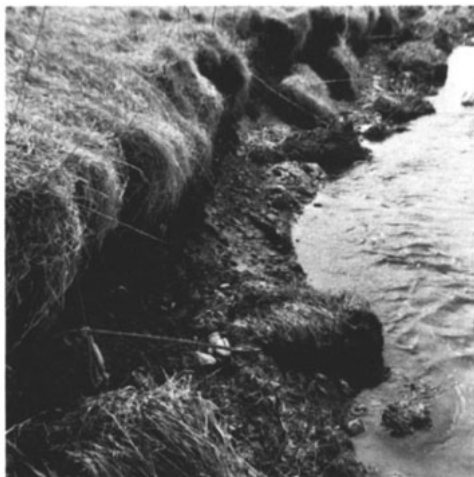
Figure 8. Closeup of retreating bank near section 44A-45 in 1971. Iron pin originally set well away from bank has been exposed by bank retreat and is now bent over into channel. Sod lumps undercut by bank retreat fall into channel.

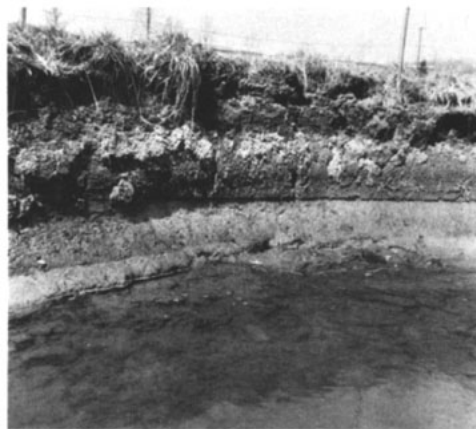
Figure 9. Stream bank which had been subject to ice crystal growth and loosening of surface layer. A moderate stream rise has removed this prepared material in lower third of the bank leaving a fresh surface of silt and showing the main mechanism of bank retreat.

The process by which this motion takes place is twofold, one erosional and one depositional. The erosion of a bank is not the result of erosion by high-velocity water, whether in a concave bank on a curve or in a straight section. Rather, for effective erosion to occur, the material must be loosened—which in this stream, is done by formation of ice crystals in winter. Crystals push soil particles out from a vertical bank of silt. When the ice crystals melt, usually on the day following formation, the grains of silt which cling to the points of growing crystals drop vertically and accumulate as a loosely structured debris cone at the base of the vertical bank. This process has been documented by Wolman (1959). The major floods occur in summer as a result of thunderstorm rain and are not effective in lateral erosion. Small rises in flow, separated by periods of freeze and thaw, are effective agents in channel migration. Details of point bar stratigraphy and its development from small increments of deposited sediments on point bars have been previously published (Leopold and others, 1964, p. 324–326).

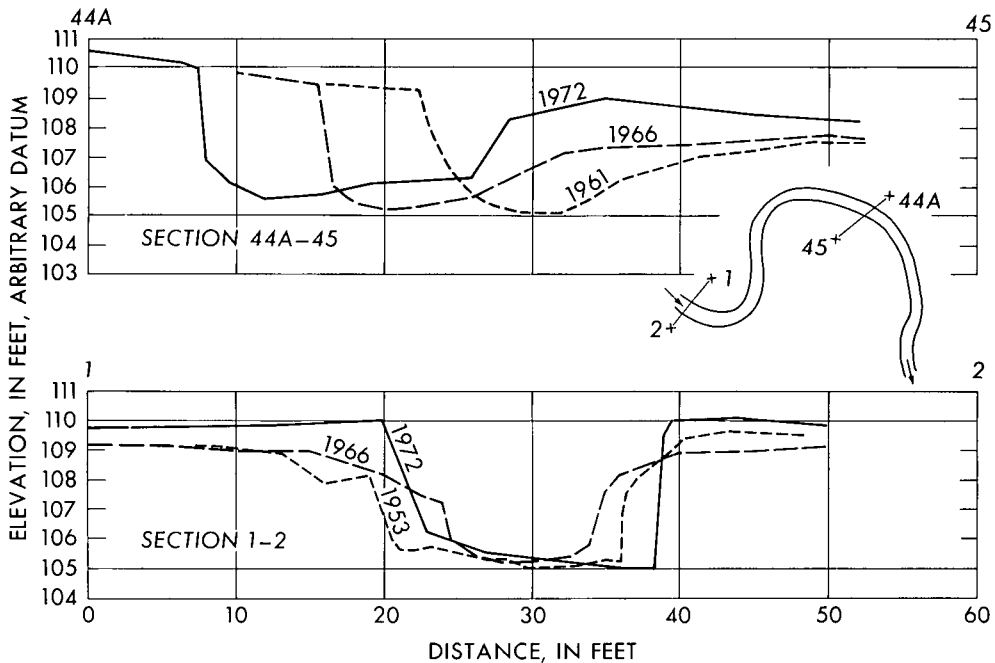
Figure 10. Selected cross sections of the channel of Watts Branch at original date of survey, an intermediate time, and 1972, section 44A-45 (upper) and section 1-2 (lower). Planimetric sketch (center) shows location of sections relative to channel bends.

The cross sections presented in Figure 10 were chosen from the 14 available to represent

two types of change. Section 44A-45 is on a long gentle curve and shows considerable migration toward the concave bank. Section 1-2 is at the end of a straight reach just upstream of a meander curve. Little lateral migration occurred there. Location of these sections relative to the plan of the study reach can be seen on Figure 2.

In 1953 on the left bank of section 1-2, there was a distinct level or berm at elevation 108. In designating the level of top of channel or bankfull, I followed the general rule that the lowest extensive flat area or definite berm on either bank would be designated. Thus, in section 1-2, the elevation of bankfull stage was in 1953, 108.0; in 1966, 108.4; and 1972, 109.9. In making the choice of top of channel, several successive cross sections were inspected simultaneously and the choices attempted to maintain a continuity in the observed changes through the whole record.

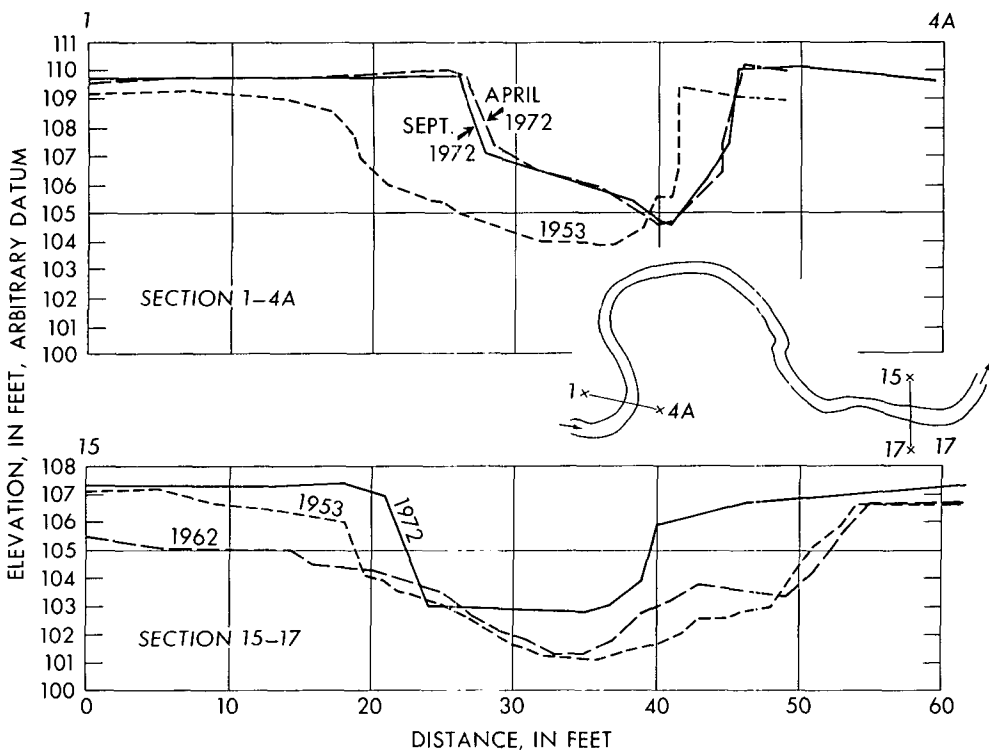
Figure 11. Selected cross sections of the channel of Watts Branch, section 1-4A (upper) and section 15-17 (lower).

Deposition in the channel was not confined to point bars convex in plan view. Section 15-17 (Fig. 11), for example progressively built both banks channelward, increasing the steepness at the same time. This occurred despite the fact that the section is located in the upstream part of a meander curve both before and after the artificial cutoff made by the sewer construction upstream in 1961.

To demonstrate that successive small rises, not large floods, account for the progressive alteration of channel, Figure 11 shows two successive surveys of section 1-4A in 1972. The surveys were made in April and September; between those surveys (in August), the largest flood of record occurred, associated with Hurricane Agnes. The section was changed so little that differences are within the usual limit of survey accuracy.

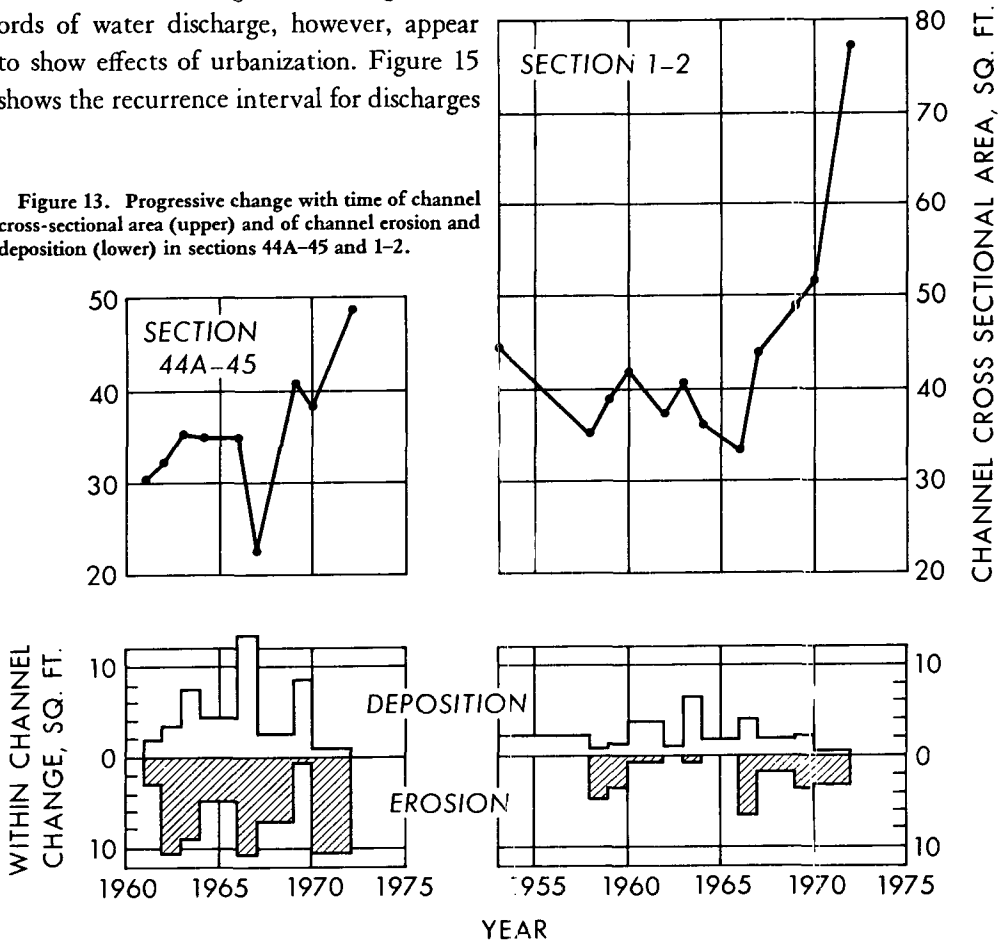
Figure 13. Progressive change with time of channel cross-sectional area (upper) and of channel erosion and deposition (lower) in sections 44A-45 and 1-2.

sectional area for two sections is plotted against time in the upper graphs of Figure 13. In 1967 at section 44A-45, a large block of turf fell into the channel from the concave bank and caused a temporary decrease in local cross-sectional area and a rise in bed elevation. Otherwise, section 44A-45 shows a tendency for some increase in area in the years prior to 1967, and section 1-2 shows some decrease in area. From 1966 to 1972, the area increased markedly in nearly all sections of which the two depicted are representative. Most sections shared with 1-2 a tendency for some decrease in area prior to 1967.

The amounts of channel erosion and deposition from one survey to another are shown in the lower part of Figure 13 for the same sections. If the channel is migrating laterally, both erosion and deposition are large as in 44A-45. An excess of erosion over deposition in the same period causes an increase in cross-sectional area.

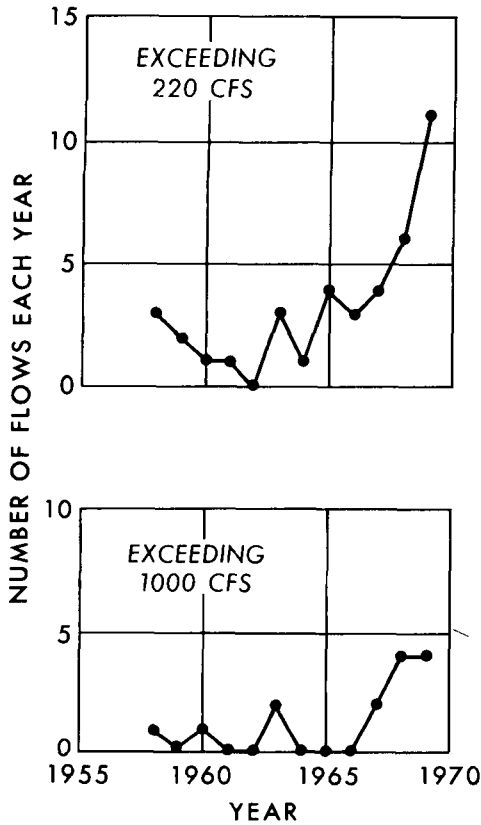
Figure 16. Number of flows equal to or exceeding two discharges, Watts Branch at Rockville, Maryland, as a function of time.

Figure 16 shows the number of flows exceeding two chosen discharge values as a function of time. The figure 220 cfs was used because it represents the bankfull discharge at a straight and natural section when the observations began. As one would expect from previous studies of bankfull stage, this discharge might be expected to be equalled or exceeded about twice each year in a natural channel. Beginning in 1965, this expected number increased dramatically. So also did the number of flows exceeding 1,000 cfs, picked merely as illustrative of flows considerably above bankfull.

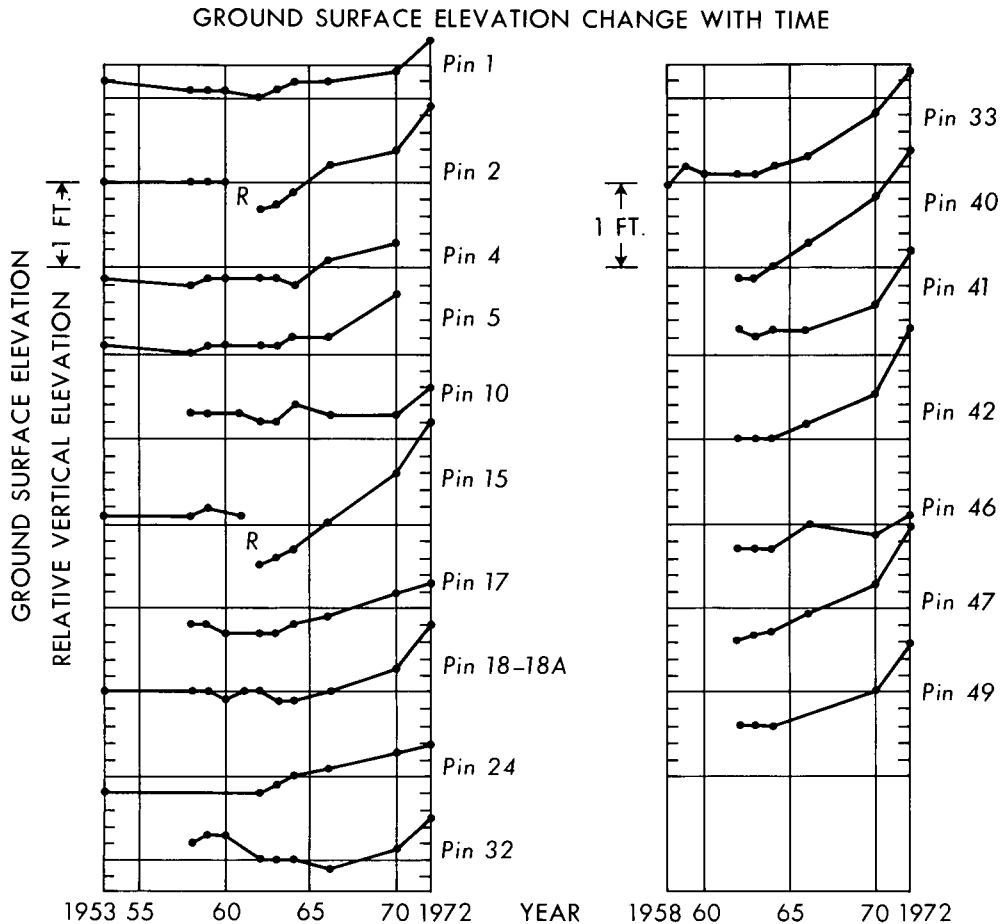
Figure 17. Ground-surface elevation change with time at location of pins monumenting the cross sections.

Figure 17 presents data on ground-surface elevation at pins marking the cross sections. Nearly without exception, these are located 10 ft or more away from the channel. The vertical scale of elevation is relative, so that the data are merely separated enough to be read. Data are plotted to the nearest 0.1 ft which is about the random variation resulting from particular placement of the rod during the survey.

Note that there was no overbank deposition accumulating at any pin location in the first 10 to 12 yrs of record. But beginning in 1966, all showed deposition which grew progressively, and even at an increasing rate at some pins. There is, therefore, a coincidence in time of overbank deposition, increase in area of channel cross section, and increase in the number of high flows per year.
