## NEGEV DESERT, CA. 2000 YEARS AGO

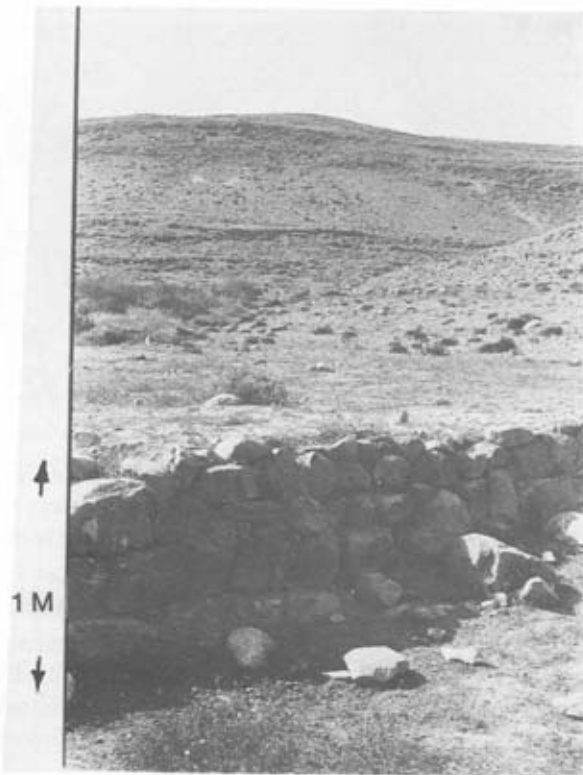
Fig. 1. Typical dam constructed nearly 2,000 years ago by the Nabatean people of the Negev Desert, Israel. The dams are typically about 1 m high, 50 m long, of rock blocks without mortar. View looking upstream across the deposited sediment. Photo by the author.

The typical dam is about 1 m high, consisting of rock blocks laid without mortar, stretching across the alluvial valley with dam length varying from 29 to 46 m. Figure 1 shows the downstream face of a typical dam. The sediment wedge behind each dam feathers out at the base of the next dam upstream, so those ancient people knew from experience the grade of deposition above a barrier.
