### 13.2 COLORADO RIVER NEAR NEEDLES, CALIFORNIA

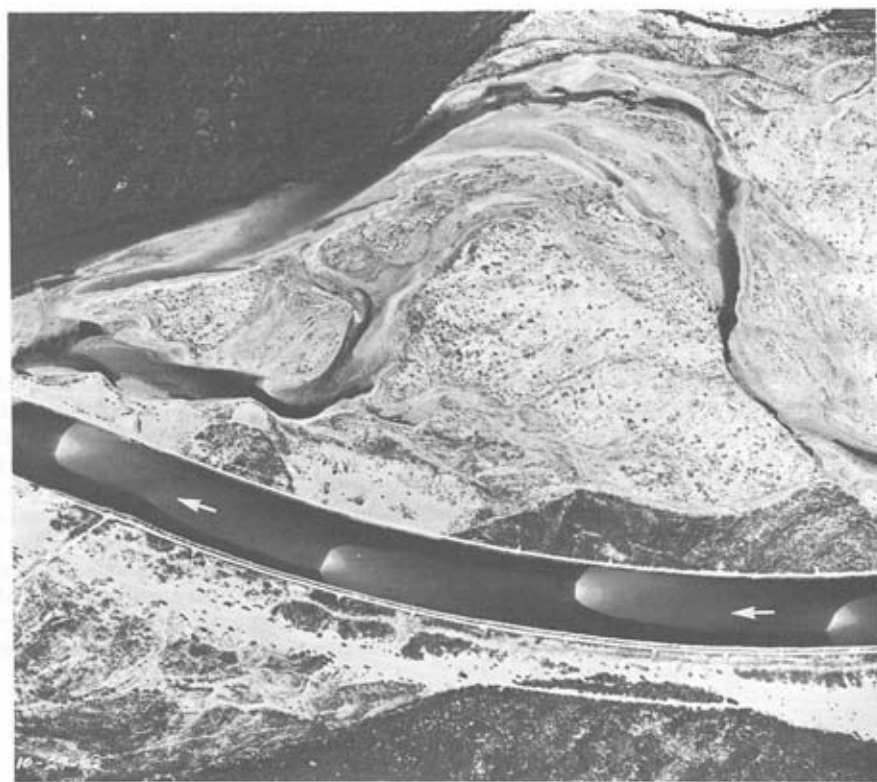
Fig. 13.1. Aerial photograph of the Colorado River near Needles, California. Controlled discharge and bank stabilization led to an unusual symmetry of moving bars on the bed. The direction of water flow is shown by arrows

The first example is one in which the complications caused by heterogeneous bank materials, irregularities of bed material, and large variation of flood discharge are minimal. The example might be considered, in a sense, to be the perfect river, or perhaps more factually, the simple river.

The construction of Hoover Dam on the Colorado River resulted not only in complete control of discharges downstream but degradation of the channel bed by the water deprived of its natural debris load. Far downstream, in the vicinity of Needles and downstream of Davis Dam, the channel width is controlled by riprap of rock or by short groins without which bank erosion would take place
