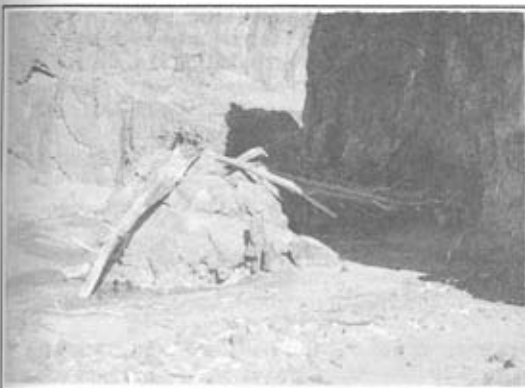
Fig. 2--Log jam caused by flood of June 1914 in Sibley Mt. box of Trujillo Arroyo, N. M.

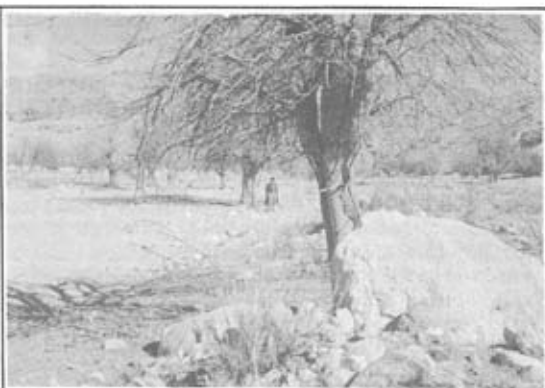
Fig. 3--Water abrasion on walnut tree in wide channel of Trujillo Arroyo, N. M.
