ALLUVIAL HISTORY OF A CHANNEL DURING SLOWLY LOWERING BASE LEVEL WHEN SEPARATED FROM THE MASTER STREAM

The Loop of the San Juan River, Utah

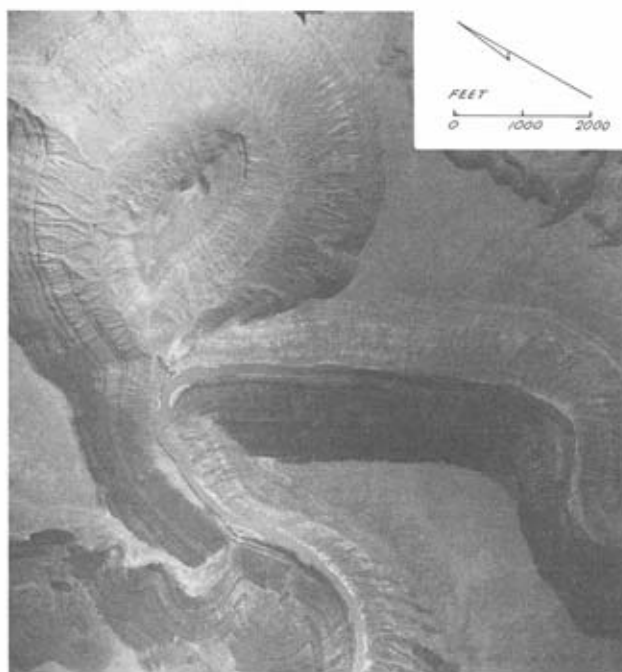
FIG. 1. Aerial photograph of the Loop, an abandoned meander, showing its relation to the present canyon of the San Juan River.

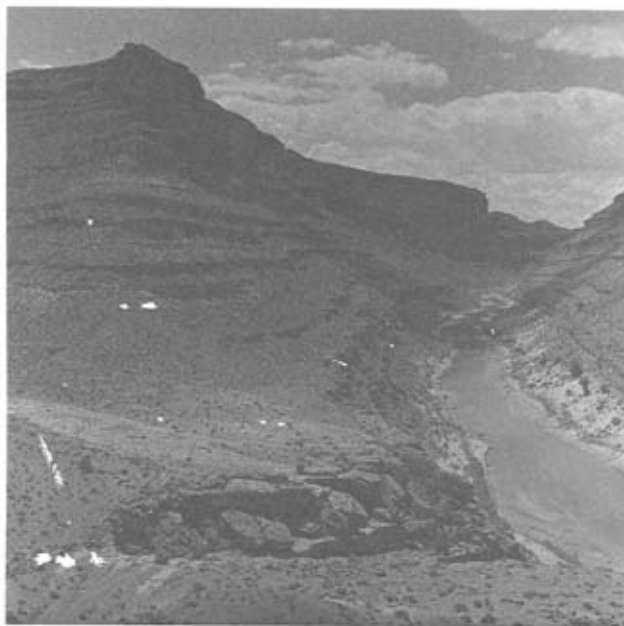
FIG. 3. View to the east from the mouth of the Loop of the San Juan River. In the foreground the two ephemeral stream channels draining the east and west sides of the Loop end abruptly at a dry waterfall, the top of which is 130 feet above the San Juan River.

The Loop is an elliptical gorge, the circumference of which along the central axis is about two miles. The Loop was cut into horizontally bedded sandstones, limestones, and shales of carboniferous age with steep, and in places vertical, bounding cliffs hundreds of feet in height. It is a cutoff meander of the San Juan River, which, since abandonment of this curve, has continued to downcut and now flows at a level 130 feet lower in elevation than it did at the time this cutoff occurred (figs. 1 and 2). The separation of the abandoned segment and the present river is in the form of a series of vertical falls over a bed of resistant rock (fig. 3).

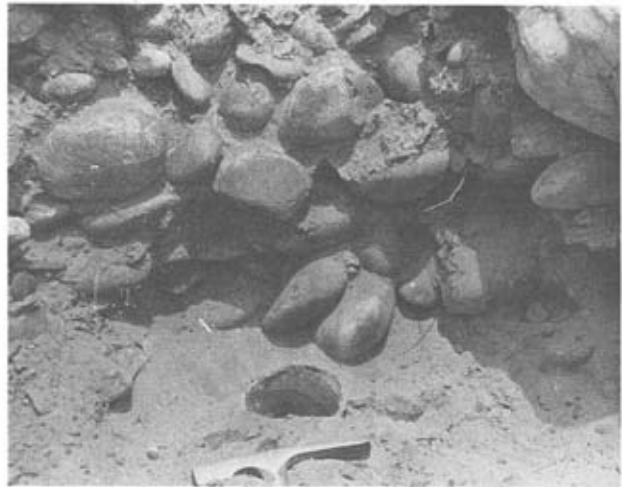
FIG. 4. Well-sorted gravel and sand deposited by the ancestral San Juan River, and exposed in the West Arroyo of the Loop.

Patches of river gravel of exotic lithologies are exposed in both west and east basins (figs. 2 and 4).

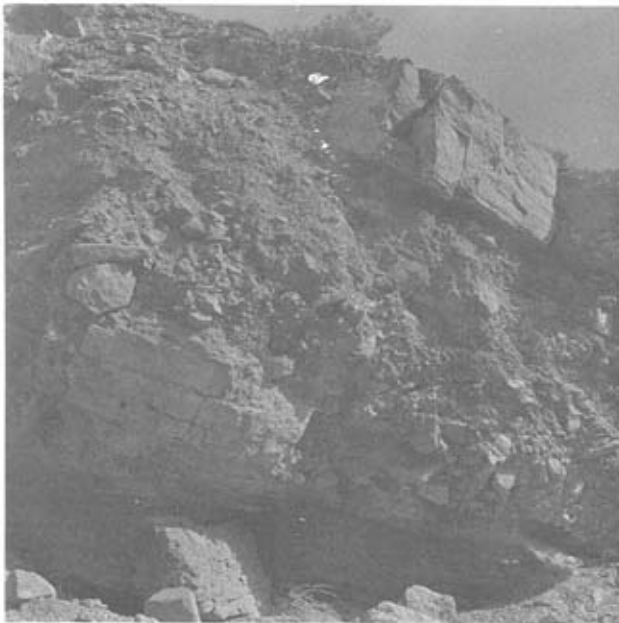
FIG. 7. View of coarse grained valley fill in the West Arroyo of the Loop at station 83+50.

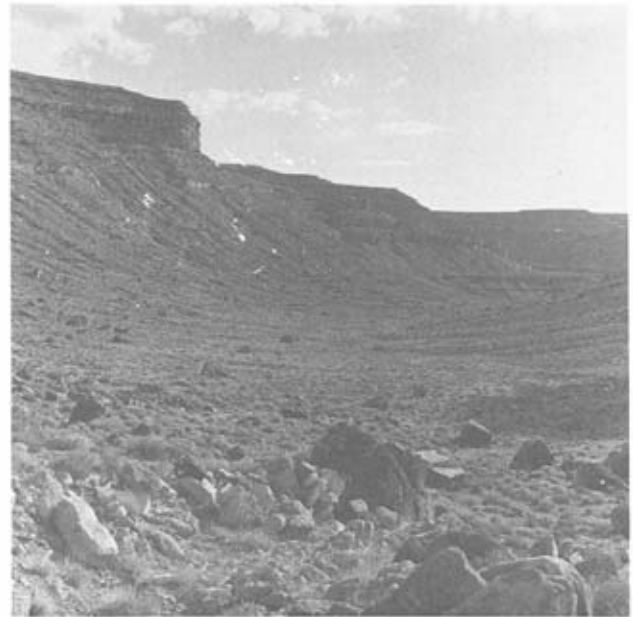
FIG. 8. View downstream of the East Arroyo of the Loop. The prominent horizontal outcrops on the ridge to the right of center in the background are part of a nose that separates the present San Juan River from the Loop.

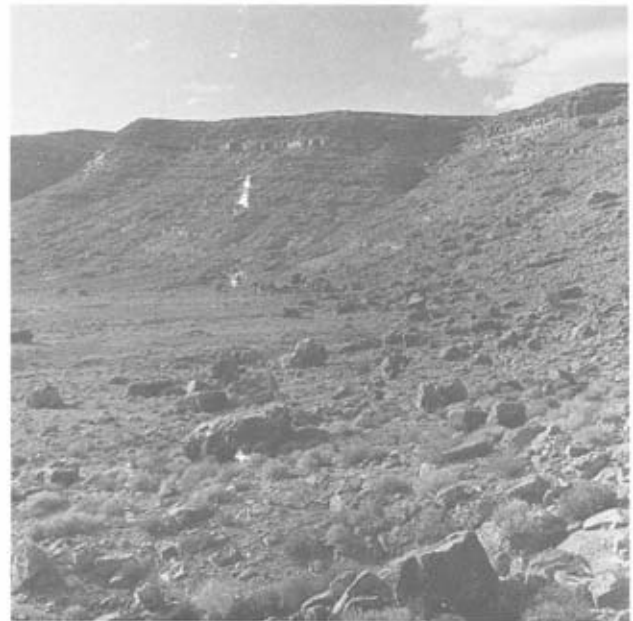
FIG. 11. Headwaters of the East Arroyo of the Loop. Sandstone blocks derived from the cliffs have accumulated at the foot of the hillslope and on the fine grained valley fill, which has a Holocene soil profile.

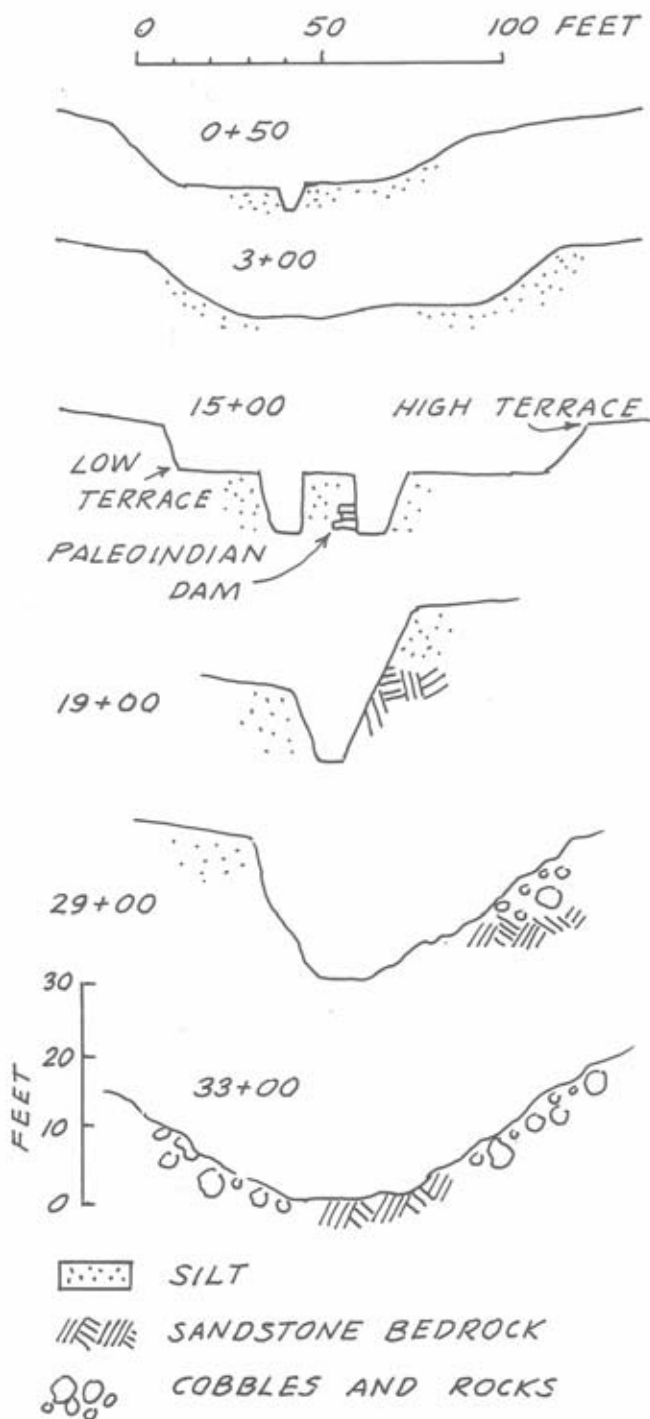
FIG. 13. Cross section of the channel of Madame Walk Arroyo at several positions along its length. Location of cross sections relative to the longitudinal profile is indicated by the distance scale (abscissa) of figure 12. Low and high terraces and present channel bed can be seen on the cross sections.

The average gradients of bedrock floor, present channel thalweg and the two terraces are all about equal at 0.033.

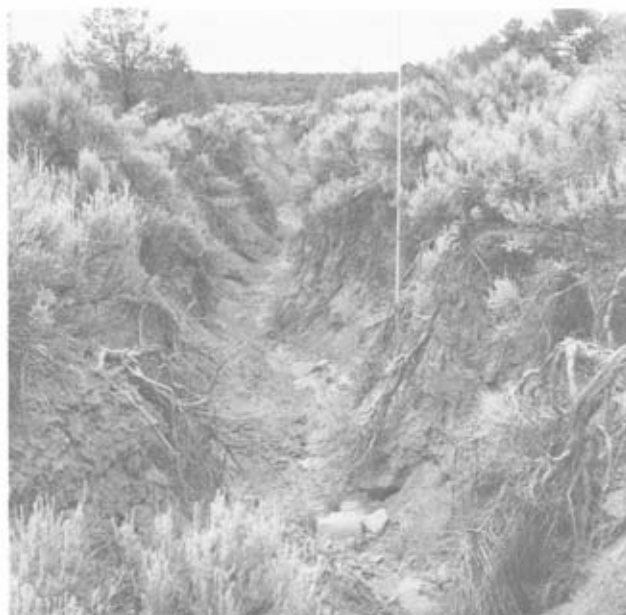
FIG. 14. Photograph of gully in Madame Walk Arroyo looking upstream at station 15+00 in vicinity of paleo-indian dams. One dam is exposed in arroyo wall near the rod in center right of the photograph.

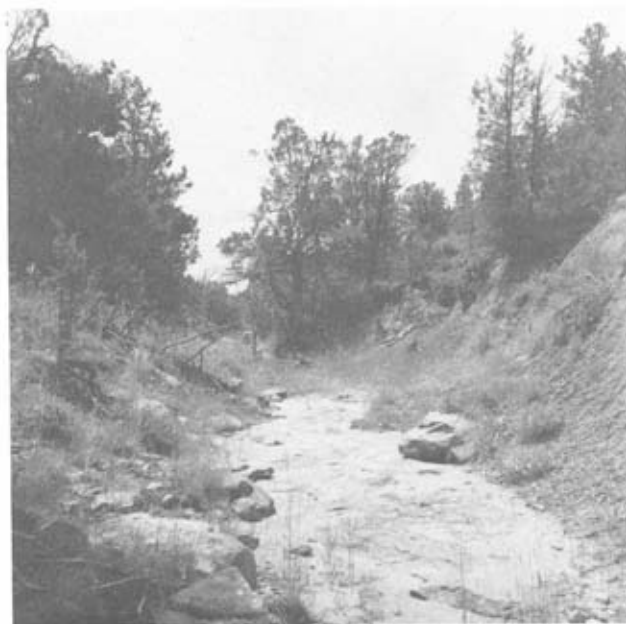
FIG. 15. Bedrock comprising the floor of Madame Walk Arroyo near station 30+00, looking downstream.

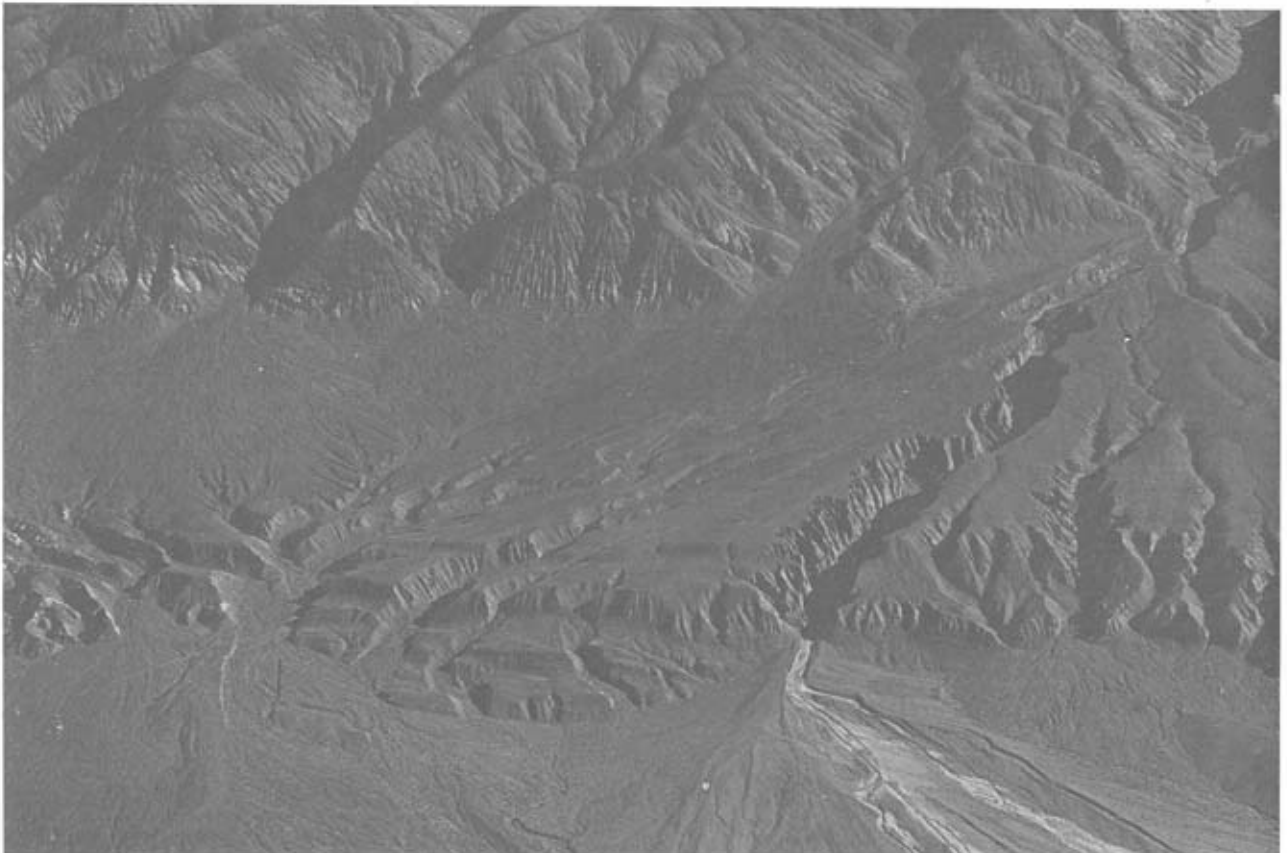
FIG. 16. Aerial view towards the east of the area where Tuber Canyon (right center) enters the Wildrose Graben, west side of Panamint Range, eastern California. Dirt road on fan at lower left provides scale as does mining camp at mountain front just to left of Tuber Canyon. The mountain-bounding fault stretches horizontally at the foot of the steep mountain in the upper part of the photograph. In the lower part of the photograph, the scarp line running horizontally across the photograph is caused by faulting of the piedmont (coalescing fans).

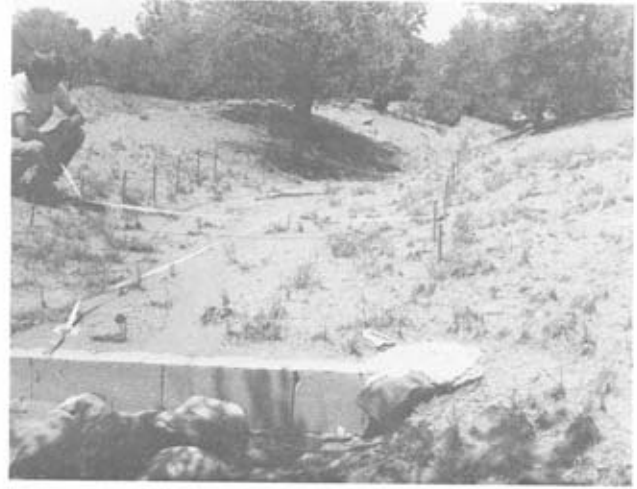
FIG. 17. Photograph of Big Sweat Dam, basin of Arroyo de los Frijoles, near Santa Fe, N. Mex. The dam is shown in foreground; view is looking upstream at wedge of sediment deposited behind the dam. Vertical rods are steel pins used as permanent markers for resurveys.

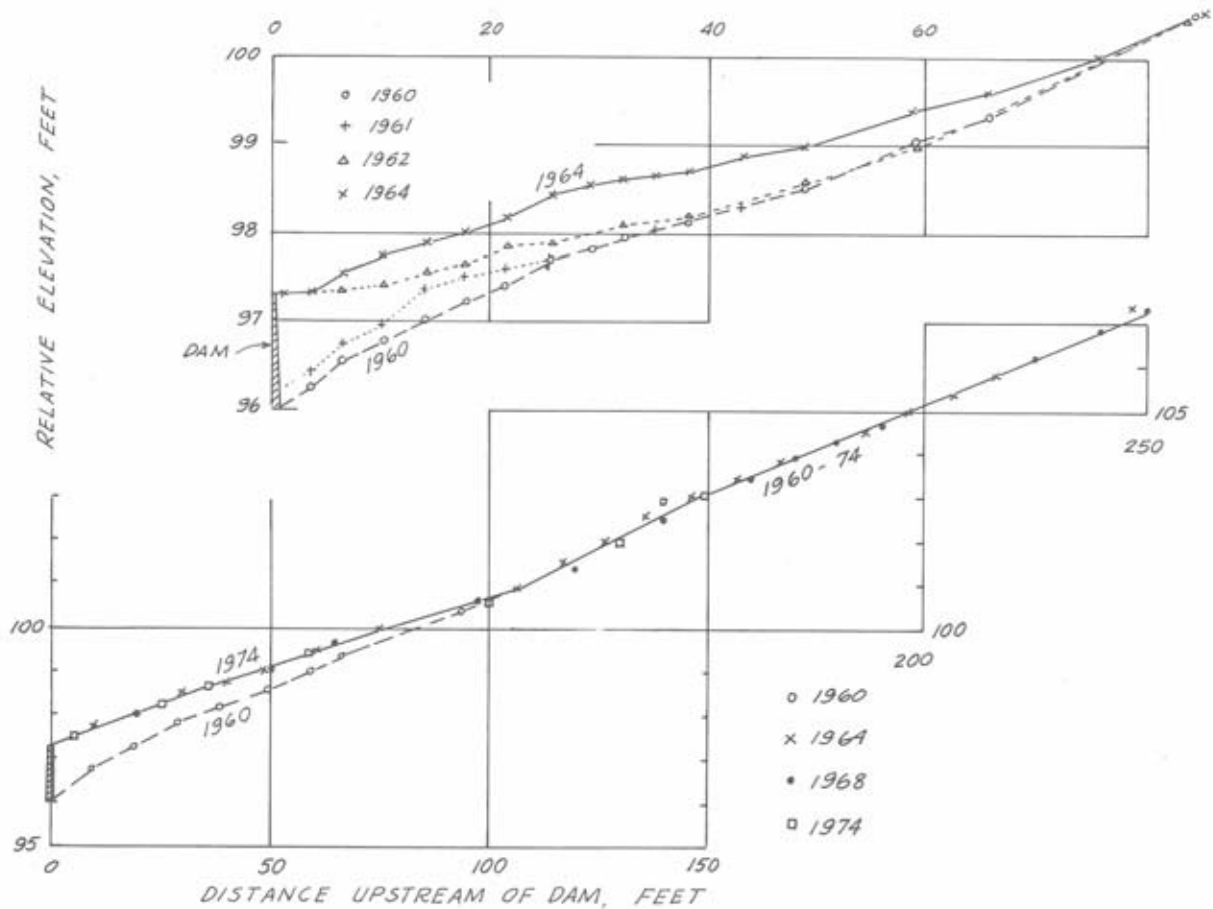
FIG. 18. Successive channel-bed profiles above Big Sweat Dam built on an ephemeral tributary to Arroyo de los Frijoles near Santa Fe, New Mexico. The upper diagram shows the progressive changes in the profile of the building sediment wedge behind the dam. The lower diagram shows less detail immediately behind the dam but at a smaller scale the relation of depositional wedge to profile upstream.

had been affected fifty feet upstream and after four years eighty feet. By that time the gradient of new deposition had attained a value of 0.033 which remained constant thereafter, a smaller value than the original gradient, 0.045. In the next ten years the gradient of deposition remained constant, and it did not extend upstream beyond one hundred feet as can be seen on the lower profile of figure 18. The progressive change with time of gradient at various distances above the dam are shown in table 1, in which it can be seen that the gradient in the reach from 110-220 feet and that in the reach 220-330 respectively were never altered by the dam.

In summary, the sediment wedge extended upstream for the first four years after which its gradient remained stable at seventy-nine per cent of the original value. The maximum distance its effect was felt was 110 feet and the dam had no effect on the other 640 feet to the watershed divide. Deposition above the other dam nearby not shown here had similar effects.
